**NONDESTRUCTIVE EVALUATION (NDE) METHODS FOR
QUALITY ASSURANCE OF EPOXY INJECTION CRACK REPAIRS**

Yajai Promboon, Ph.D., Larry D. Olson, P.E.
Olson Engineering, Inc.
and
John Lund, P.E.
Martin/Martin, Inc.

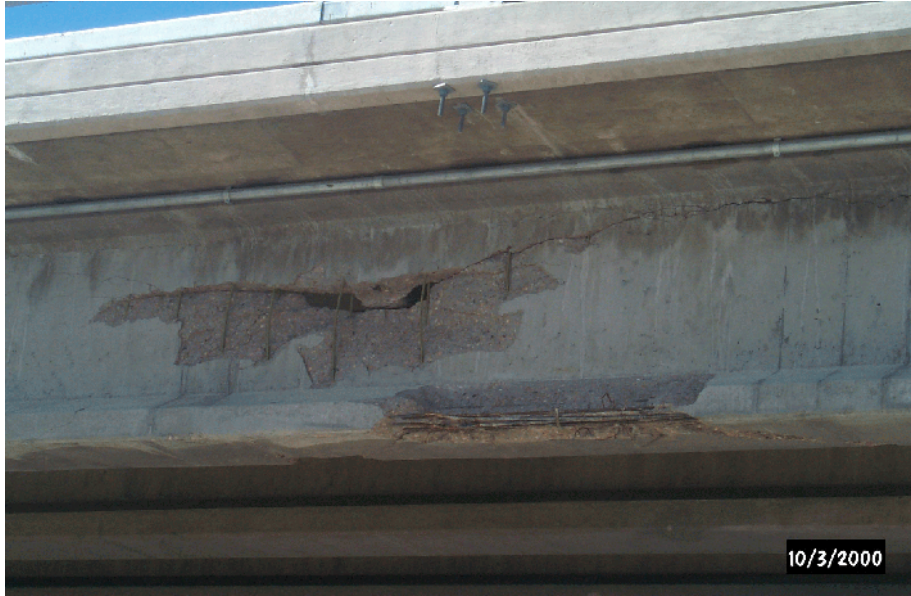
A concrete bridge over westbound Interstate 70 just outside Denver, Colorado, was recently impacted by a forklift carried by a truck moving at a speed of approximately 75 mph. The impact resulted in cracking and concrete spalling on both sides of the easternmost prestressed concrete I-beam bridge girder. The damage was most severe on the east side of the girder where the impact occurred, as shown in Fig. 1, although significant cracking was also seen on the west side of the girder as well. Epoxy injection and a concrete patching material were used to repair the cracks in the damaged girder. After the repairs were complete, a nondestructive testing program was developed to help assure the quality of the repairs by checking for areas of unfilled cracks. The nondestructive testing program used in this investigation consisted of Impact Echo (IE), Ultrasonic Pulse Velocity (UPV) and Spectral Analysis of Surface Waves (SASW). Since a combination of IE and UPV tests was found to be most effective in characterizing unfilled cracks in this repaired concrete bridge girder, this paper focuses on the combination of these two methods. The SASW tests were used in a more limited role in this investigation, primarily in areas with unfilled vertical cracks to increase the confidence level in the quality assurance program. The nondestructive tests used for this quality assurance cannot determine the bond strength of the epoxy material used in the repairs, but can identify areas of unfilled cracks. Repair procedures, brief backgrounds of the IE and UPV test methods, the nondestructive field investigation and the results are presented herein.

Fig. 1 - Damage on the Eastmost Concrete Girder before the Repairs

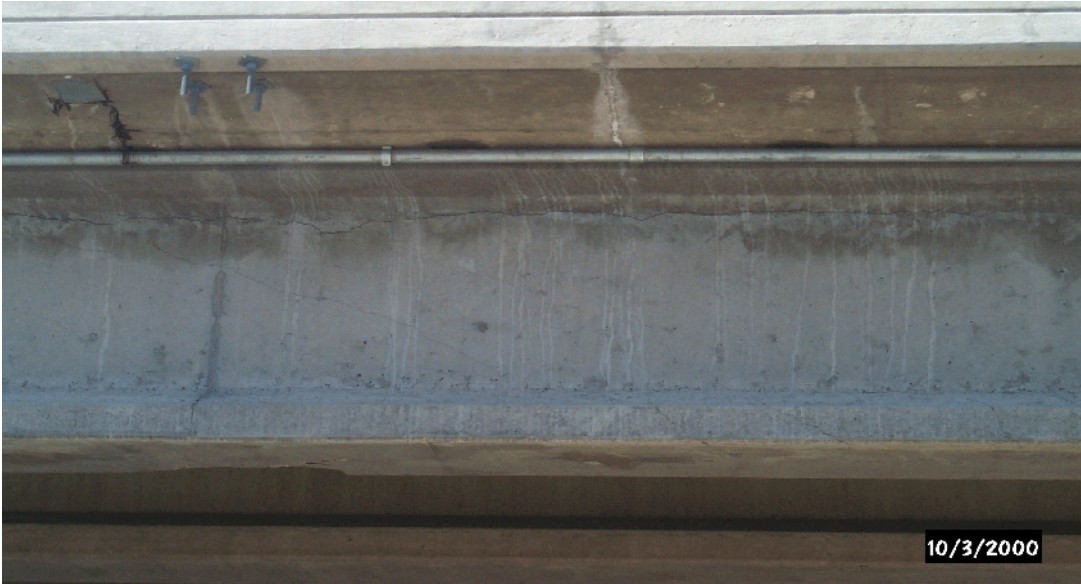
The impact on the bottom flange of the bridge girder caused the girder to rotate inward toward the center of the bridge. The rotation was resisted by the concrete diaphragm attached to the web of the girder, causing a large amount of spalling and cracking to occur in the region of the diaphragm. The full depth and partial depth spalled web areas were repaired by chipping out all loose or damaged concrete using light (15 pound) electric chipping hammers so that the repaired areas were approximately rectangular in shape. Edges of the repaired areas were cut perpendicular to the girder a minimum of $\frac{3}{4}$ " deep. The repair area was pre-saturated with water and the surface allowed to air-dry to a saturated surface dry condition. Master Builders Emaco S77 structural repair mortar was installed using the form and pour method and cured for seven days. After the web repairs were complete, the bridge girder was pre-loaded and the bottom flange repairs were completed as detailed above. After the web and flange repairs were complete, approximately 800 lineal feet of cracks were injected with Master Builders Concesive 1380 Injection resin (Fig. 2 shows beam prior to epoxy

Fig. 2 - The Damaged Girder Prior to Epoxy Injection Repairs

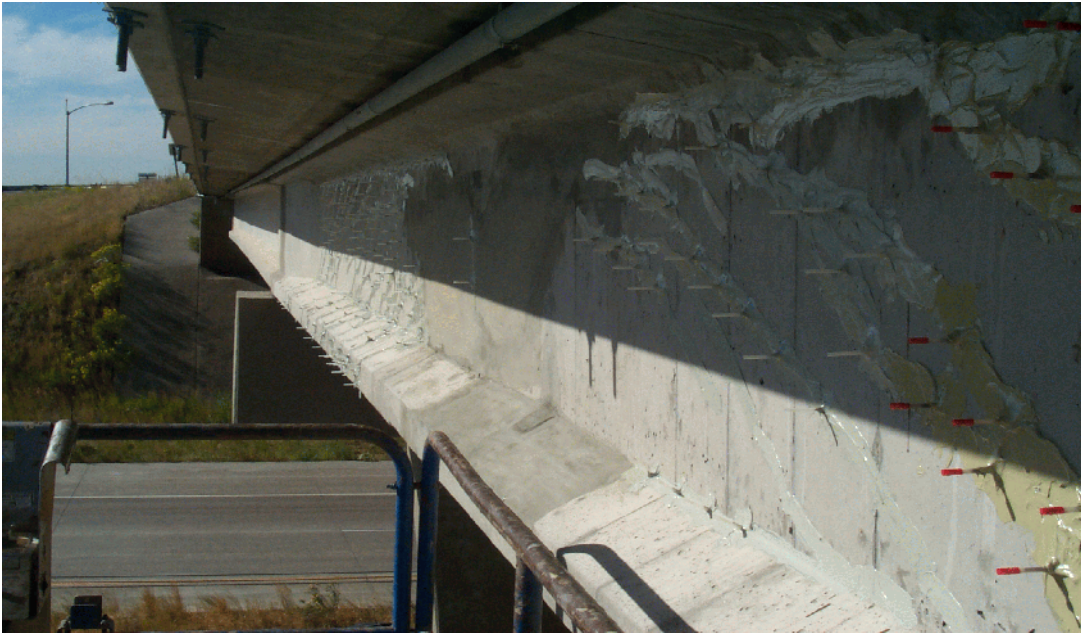
Fig. 3 - The Damaged Girder with Injection Ports in place

injection, Fig. 3 shows injection ports in place). As part of the overall quality control process, inspections were performed by the structural engineer prior to placement of repair mortar and at other critical times during the repair work.

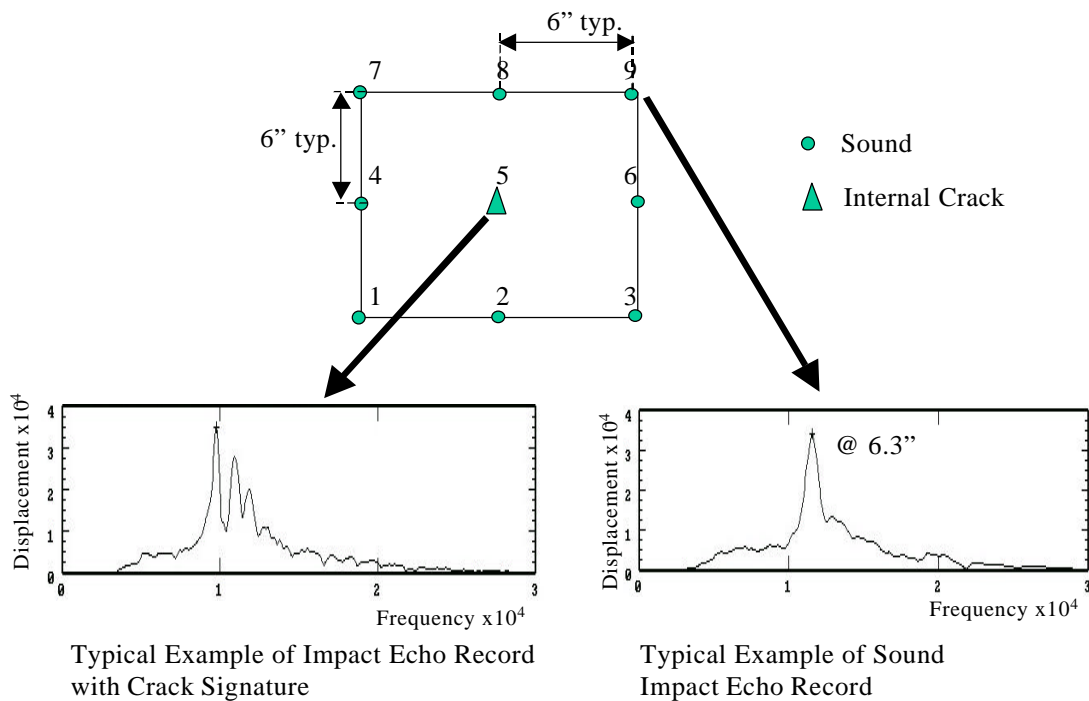
This section presents example IE and UPV results from one test station (Station O) on the repaired bridge girder. The graphical IE frequency results from Station O on the web area are shown in Fig. 8. The IE data from Location 5 shows a signature of internal cracking (unfilled) as can be seen by multiple echo peaks in the frequency domain. A typical IE record indicating sound concrete at Location 9 is also included in Fig. 8. Data from the rest of the tested points on Station O were similar to data from Location 9, indicating sound concrete with no internal cracks. The typical sound concrete record from Location 9 shows a resonant echo peak from the back wall of the web at a frequency corresponding to a depth of 6.3 inches (using Eq. 1) which is close to the design thickness of 6.0 inches. The IE record with a crack signature shows multiple peaks resonating from different depths indicating a strong possibility of unfilled, internal concrete cracking at that point.

Fig. 8 - Example Impact Echo Results Showing Records of Sound Concrete and Cracked Concrete

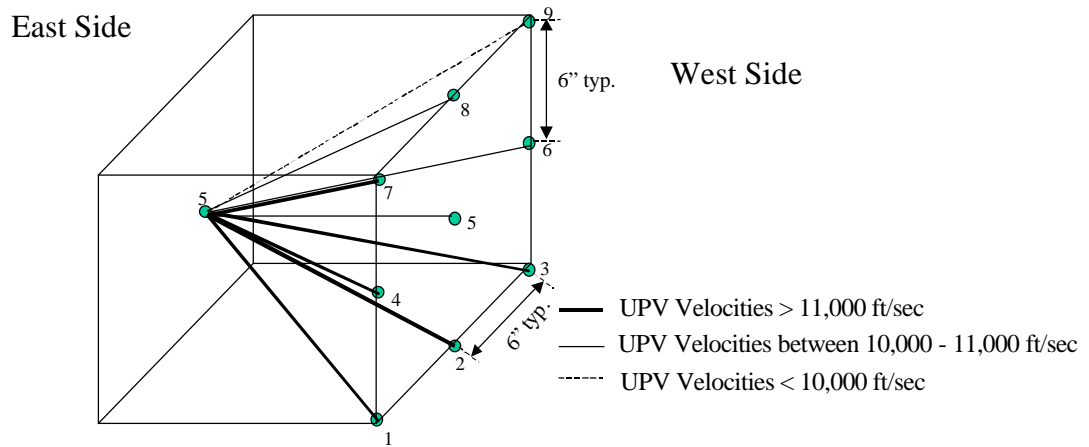
Graphical UPV test results from Station O are presented in Fig 9. The UPV results were classified into 3 categories based on the UPV velocity results. The first category was when the UPV velocities were greater than 11,000 ft/sec. The second category was when the UPV velocities were between 10,000 and 11,000 ft/sec. The last category was when the UPV velocities were below 10,000 ft/sec. As discussed earlier, higher velocities normally indicate higher concrete quality. For Station O, the UPV velocity results indicated that the concrete qualities for Paths 5-1, 5-2, 5-3, 5-4 and 5-7 had higher concrete quality, the concrete qualities for Paths 5-5, 5-8 and 5-6 were lower quality, and those of Path 5-9 were in the lowest quality category.

Fig. 9 - Example Ultrasonic Pulse Velocity Results from Station O

Based on the UPV results, an area of unfilled cracks was located on the south corner of Station O. From the IE tests, the results from Location 9 were sound with no internal cracks. Taken together, the nondestructive evaluation (NDE) results showed that the unfilled cracks lie in angle across Paths 5-5, 5-6, and 5-9 with wider open area between Path 5-9 and tighter crack tip between Path 5-5. The unfilled cracks did not appear to spread to the south end (Location 9) of Station O since the IE results from Location 9 were sound.
