Nondestructive evaluation of concrete dams and other structures

Larry D. Olson, P.E. (Presenter); Dennis A. Sack

Olson Engineering, Inc.
14818 W. 6th Ave Unit 5A, Golden, CO 80401

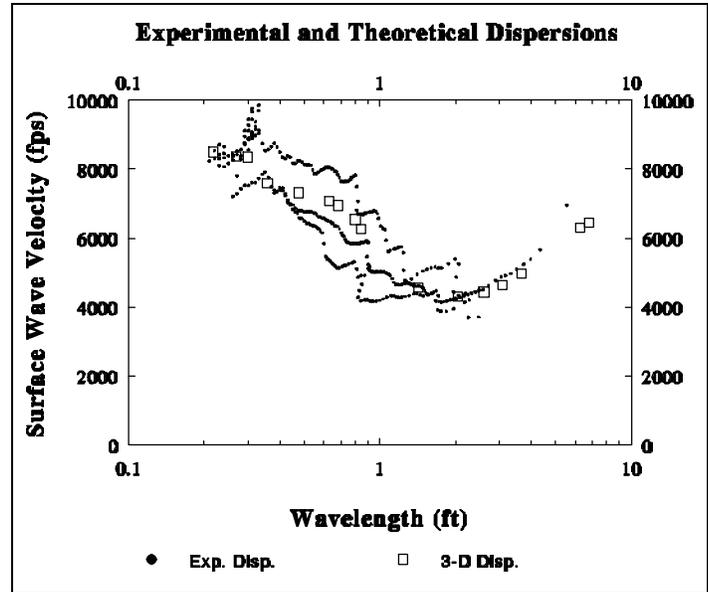
Sample SASW dispersion curve and velocity profiles are presented in Figs. 4 and 5 for a location with sound surface material, followed by a layer of degraded concrete, below which is sound core concrete. The field dispersion curve data, and 2-D and 3-D (more accurate) theoretical analysis, produced dispersion curves as presented in Figure 4 followed by the shear wave velocity profile versus depth plot in Fig. 5. The dispersion curve is plotted with surface wave velocity on the vertical linear axis scale and wavelength in feet on a horizontal logarithmic (base 10) scale (Fig. 4). The theoretical shear wave velocity profile is plotted on a linear scale with velocity on the horizontal axis and depth of each analysis layer on the vertical axis in feet (Fig. 5).

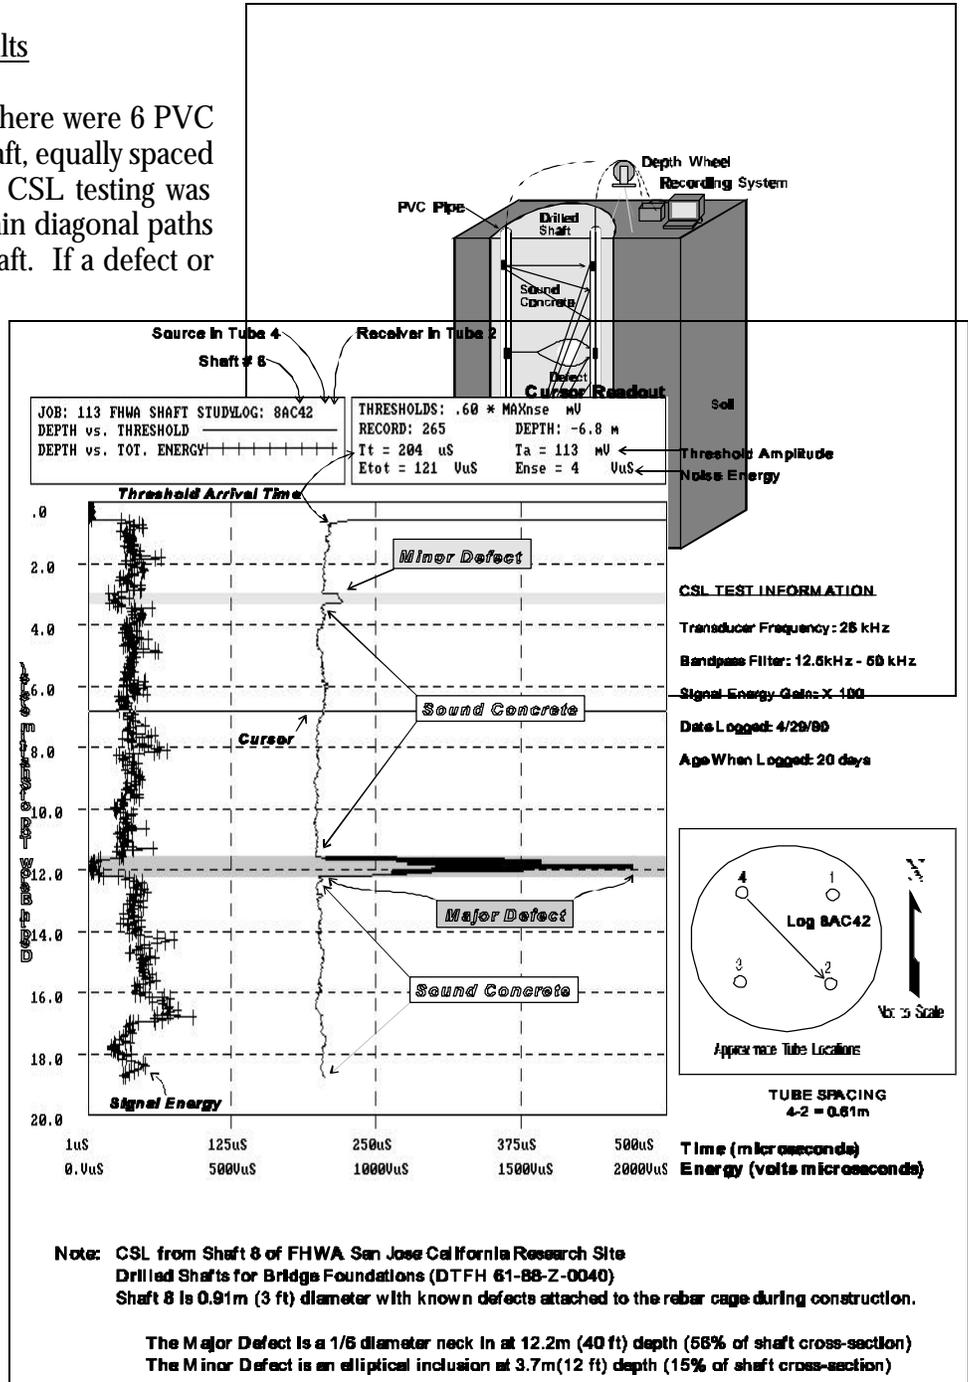
Analyses to evaluate the integrity of the concrete include measurement of wave travel times between the source and receiver, calculation of corresponding wave velocity, and receiver response energy. Longer travel times and corresponding slower velocities are indicative of irregularities in the concrete between the tubes, provided that good bonding is present between the tubes and concrete. The complete loss of signal is indicative of a significant defect in the concrete between one or more tube pair combinations. An example log, with annotations, from a typical CSL test of a shaft with known defects is presented in Fig. 7.

A major defect was identified in Shaft 39 Left. CSL, angled CSL, and Singlehole Sonic Logging (SSL) were used to define the defect in this drilled shaft. The final analysis of the logs indicated the defect was located at 3.0 to 3.6 meters (10 to 12 feet) below the shaft top, which is immediately below the hinge cage (upper rebar cage). The defect was identified in the center of the shaft, which ruled out the possibility of a soil intrusion or other caving problem. Review of the inspection logs revealed that the driller had been unable to place the hinge cage deep enough in the shaft during concrete placement. The hinge cage was then removed and small 1.22 meter (4 foot) bucket was used to drill down the center of the shaft to the necessary depth. A new hinge cage was set in place and concrete placement was completed. Therefore, it was

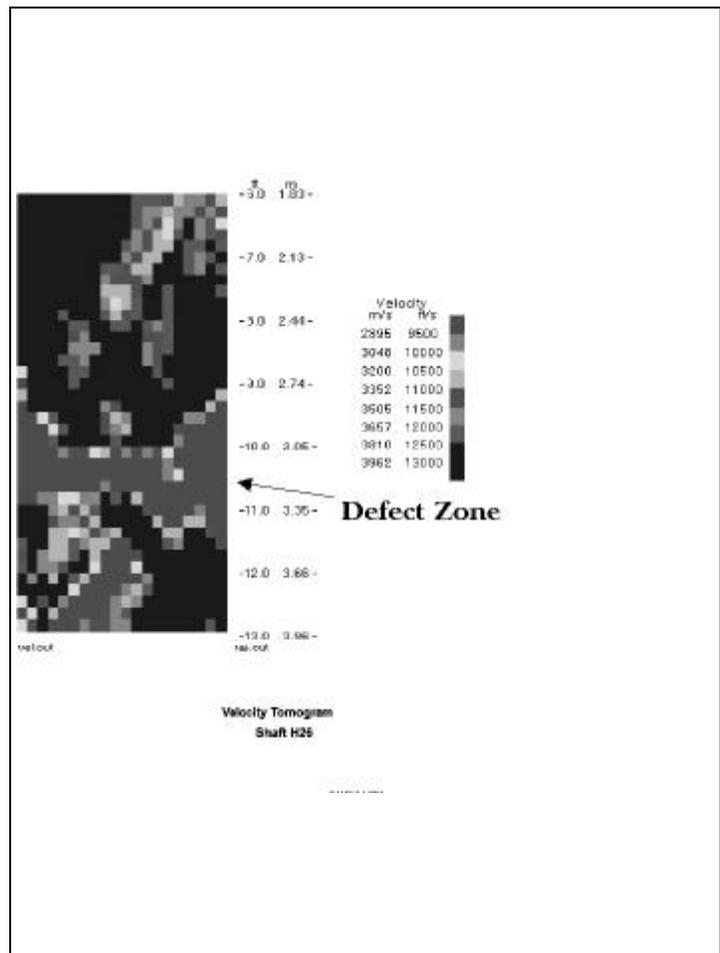
The CSL testing on the LA Green line was performed before the development of tomographic techniques (7) that could be applied to deep foundation defect imaging. If the techniques had been available for imaging the defect in Shaft 39, much of the uncertainty about the defect, and the subsequent coring, might have been avoided. The tomographic processing technology was used recently on a drilled shaft foundation for which a defect was located during routine CSL quality assurance testing. The CSL test results indicated a defect between 9.5 and 11 feet below the top of the shaft, but could not define the shape or exact cross-sectional location.

To better define the defect, a tomographic data set was collected along a path which intersected to largest extent of the defect, and a tomogram produced. Collection of the data required about 45 minutes of field time to collect data for several thousand unique ray paths. Tomographic analysis requires this many unique paths to construct an accurate image. It should be noted that prior to the development of

The resulting tomogram from the shaft is presented in Fig. 8. This tomogram is a plot of material compression wave velocity versus 2-D position in the shaft concrete. A sound concrete shaft would show a constant color shade throughout the interior. The tomogram in Fig. 8 shows a clear cross-section of the defect just below the center of the tomogram. It should be noted that shaded areas near the top and bottom of the shaft are artifacts of the processing program, and do not represent real data. Artifacts are common at the top and bottom of tomograms due to the sparcity of the data density at these locations. In other words, artifacts result because fewer data ray paths cross the top and bottom of the tomogram area. The defect, evident as a lighter-shaded area below the center of the diagram, is in an area of high ray density, and is an accurate representation of the expected shape of the defect. For this shaft, the tomogram showed that the defect does indeed cover the complete shaft cross-section along this vertical slice. The CSL method alone, while fast and relatively accurate, can only give the height extent of the defect and approximate the area affected. Tomography can indicate where and how extensive the defect is in the shaft cross-section, as well as giving it's shape.

Because of the unusual construction circumstances and the location of the defect in the shaft, four NX cores were cut down through the defect zone. Review of the cores show that each core was broken at the defect zone and had some gravel retrieval in the defect zone. It was uncertain if the cores broke during drilling or if there was a weaker material in the indicated defect zone. Additional CSL logs were performed between the coreholes. The results again indicated a serious defect in the shaft center. High pressure grout was then injected into the coreholes to attempt remediation. Grout flow between the coreholes was observed at this time. Subsequent CSL testing between additional coreholes indicated that the problem remained. Finally a 0.5 meter (20 inches) core was taken down the shaft center. This revealed that air bubbles the size of pin heads had been whipped into the concrete. This 'whipped' concrete was extremely light weight and could be easily crushed with bare hands. Apparently, the bottom of the smaller drilled out hole was not adequately cleaned out before the new concrete was placed. The final remediation to the shaft required the removal and replacement of the top 3.6 meters (12 feet) of the shaft.
