Impact-Echo Scanning for Grout Void Detection in Post-tensioned Bridge Ducts - Findings from a Research Project and a Case History

(presented at ASCE Structures Congress, Long Beach, California, May 2007)

Yajai Tinkey, Ph.D., Olson Engineering, Inc., 12401 W. 49th Ave. Wheat Ridge, CO 80033, USA, yajai@olsonengineering.com

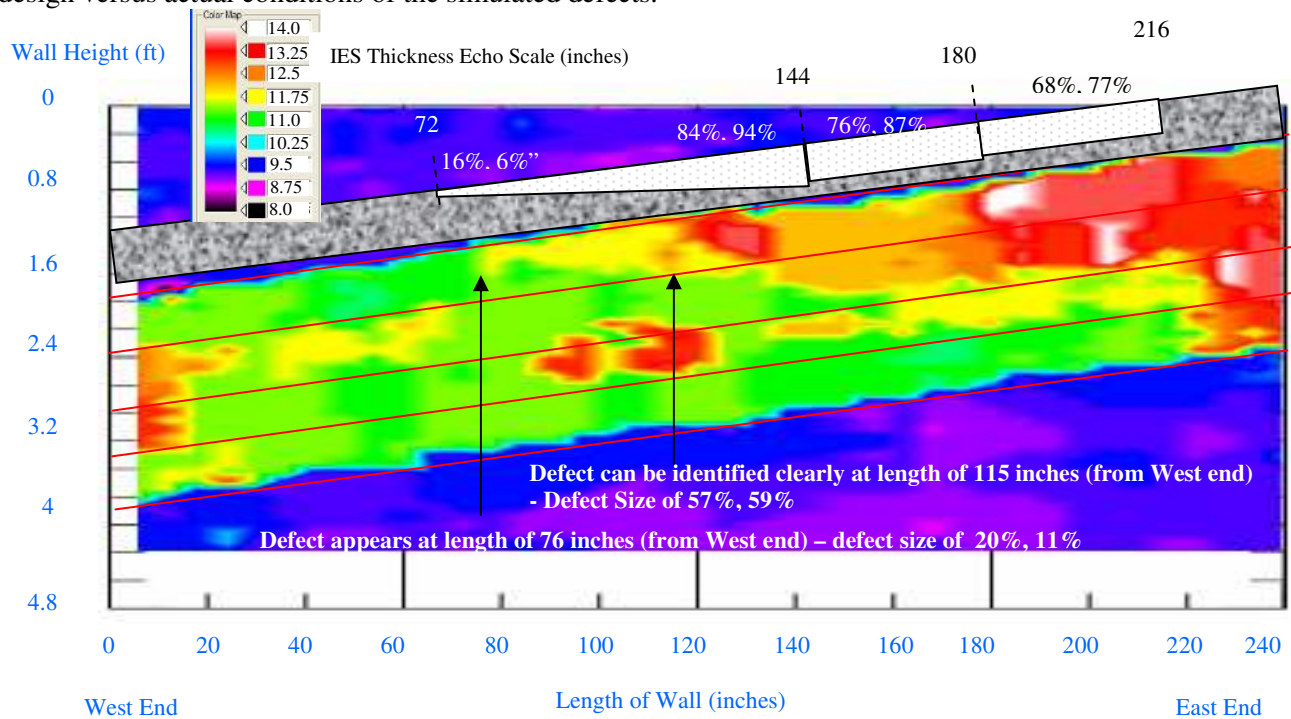
South Wall – Top Duct: The IE Scanner results from the South Wall with the actual defect design of the top duct placed above the IE results of the top duct are shown in Figure 5. The results are interpreted to indicate that the grout defect started to appear at a length of 1.93 m (76 in) and becomes clearly evident at length of 2.92 m (115 in) from the west end of the duct. The location that the defect starts to appear corresponds to void with 11% depth lost or 20% circumferential perimeter lost. The location that the grout defect become more evident corresponds to void with 59% depth lost or 57% circumferential contact diameter lost. The dominant frequency of the fully grouted duct is approximately 6.4 kHz, resulting in an apparent Impact-Echo thickness of 28.37 mm (11.17 in.). The dominant frequency shifted downward to approximately 5.37 kHz for an empty duct, which corresponds to an apparent Impact-Echo thickness of 340 mm (13.4 in). This is a relatively large thickness shift of over 30% compared to the nominal thickness of the wall. The interpretation of the Impact-Echo Scanner results, however, shows a downshift in frequencies from lengths of 5.49 to 6.1 m (216 to 240 in), indicating voids at duct locations where no discontinuities were intentionally placed. It is likely that grout did not flow into the higher east duct end due to the big voids in front of it. Radiographic tests will be performed in the future to verify the design versus actual conditions of the simulated defects.

FIGURE 5 – IE RESULTS FROM THE SOUTH WALL WITH ACTUAL DESIGN DEFECTS OF TOP DUCT

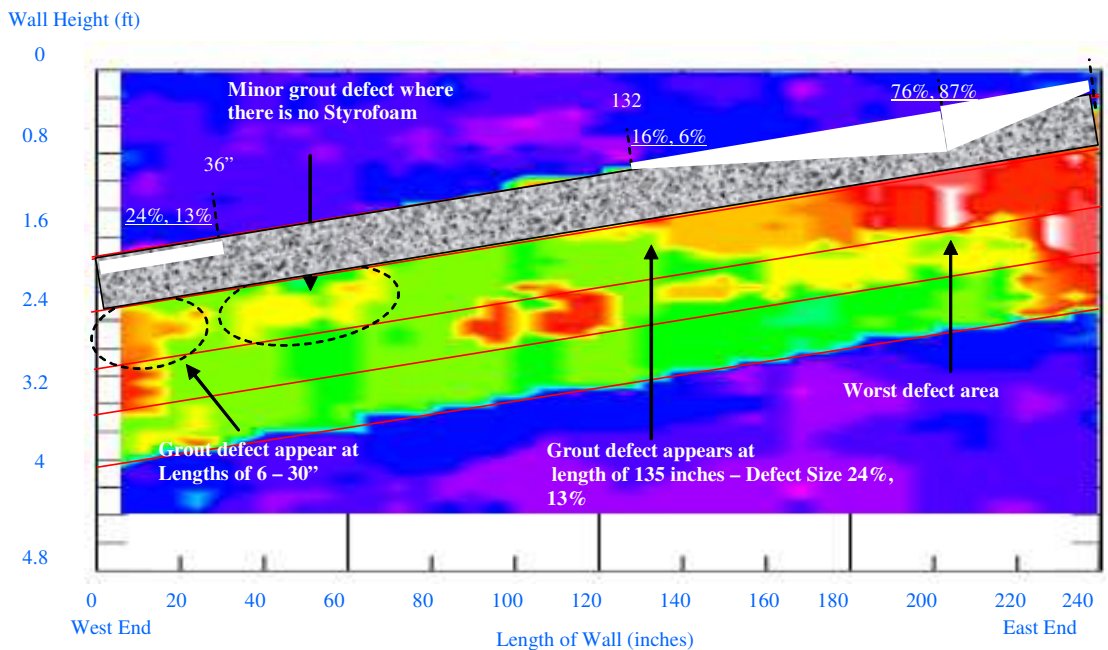
South Wall – Second Duct from Top: Review of Figure 6 shows that there are three grout defect zones. The first grout defect zone correlates with the end defect (13% depth lost or 24% circumferential lost). The second defect zone shows minor grout problem from lengths of 0.91 – 1.67 m (36 – 66 in) from the west end of the duct. However, there is no actual defect placed in this area. Radiography is required to confirm the realization of defect designs. The third defect zone appears at a length of 3.35 m (132 in) which corresponds to defect of 9% in depth lost or 18.5% in circumferential lost. The most apparent grout defect appears at a length of 5.18 m (204 in) corresponding to the location of the largest Styrofoam in the duct (87% depth lost or 76% circumferential perimeter lost). Similar to the results from the top duct, the interpretation of the Impact-Echo Scanner results, however, shows a downshift in frequencies from lengths of 5.18 to 6.1 m (204 to 240 in), indicating major voids at duct locations where actual defect shape tapers down toward the east end. It is likely that grout did not flow into the east end due to the large voids in front of it.

FIGURE 6 – IE RESULTS FROM THE SOUTH WALL WITH ACTUAL DESIGN DEFECTS OF SECOND DUCT

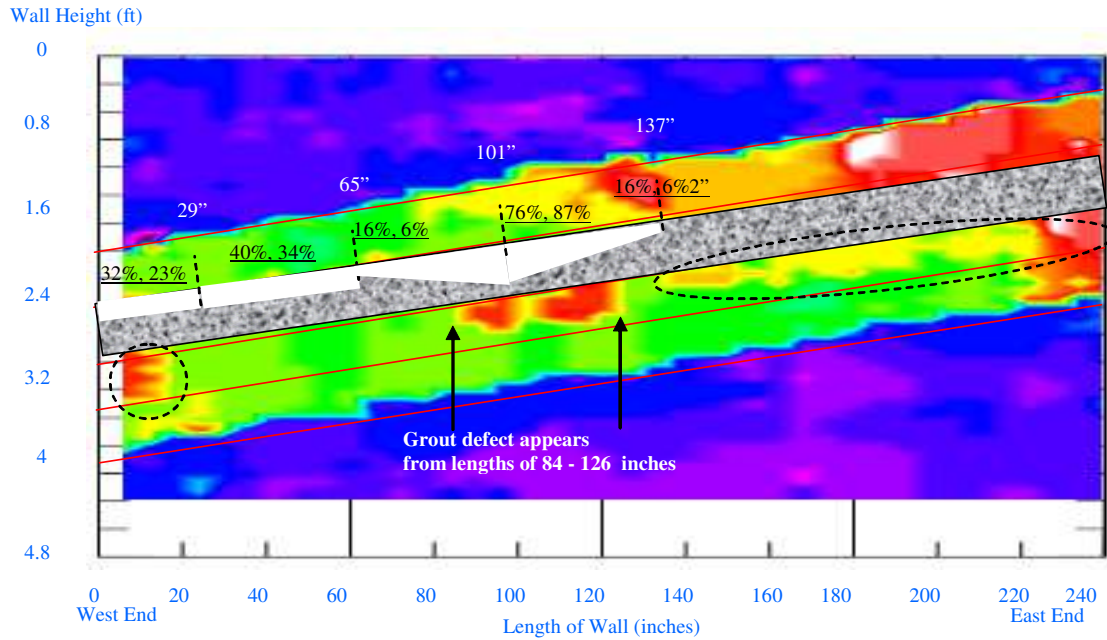
South Wall – Third Duct from Top: Figure 7 shows three zones of grout defects. The first area is located at the west end where Styrofoam Defect ID# 3 (see Table 1) is in place. However, the IE results show that the duct is fully grouted between lengths of 0.45 – 2.13 m (18 – 84 in) from the west end where there are actual Styrofoam defects placed in these locations. The grout defect appears again between lengths of 2.13 – 3.2 m (84 – 126 in). The starting location of the second defect zone corresponds to actual defect of 49% depth lost or 48% circumferential lost. The end location of the defect zone corresponds to actual defect of 30% depth lost or 34% circumferential lost. The interpretation of the Impact-Echo Scanner results, however, shows a downshift in frequencies from lengths of 3.48 – 6.1 m (137 to 240 in), indicating minor to major voids at duct locations where no actual Styrofoam defect in place. Radiography is required to confirm the actual location of Styrofoam voids.

FIGURE 7 – IE RESULTS FROM THE SOUTH WALL WITH ACTUAL DESIGN DEFECTS OF THIRD DUCT

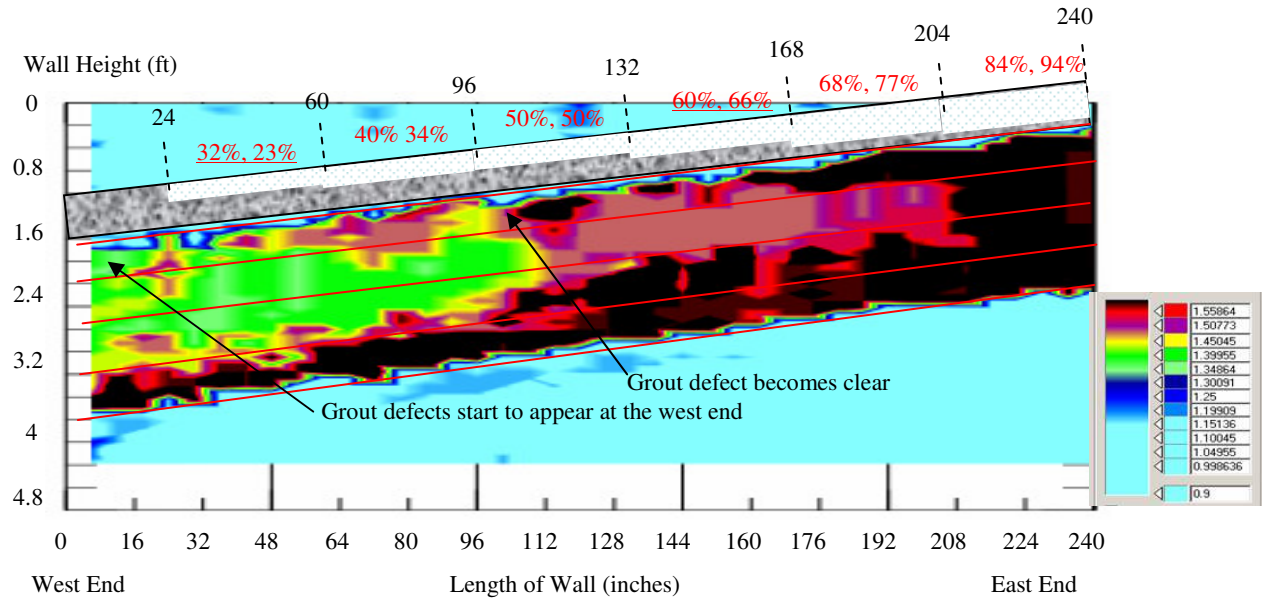
North Wall – Top Duct: The IE results from the North Wall with the actual defect design of the top duct placed above the IE results of the top duct are shown in Figure 8. Several pieces of stepped Styrofoam were inserted inside this duct ranging from depth lost of 23% to 94% or circumferential lost of 32% to 84%. All the results from four ducts from the North wall are presented with normalized thickness tomogram. The results are interpreted to indicate that the grout defect started to appear at the west end of the girder although there was not Styrofoam inside the duct for the first 6.10 m (24 inches) from the west end. However, visual inspection indicated there was honeycomb around the top duct of the north wall. Figure 8 showed that the IE test was able to detect the grout defect of 23% depth lost or 32% circumferential lost. The location that the grout defect is more evident corresponds to void with 50% depth and 50% circumferential contact diameter lost.

FIGURE 8 - IE RESULTS FROM THE NORTH WALL WITH ACTUAL DESIGN DEFECTS OF TOP DUCT AND THE NORMALIZED THICKNESS SCALE

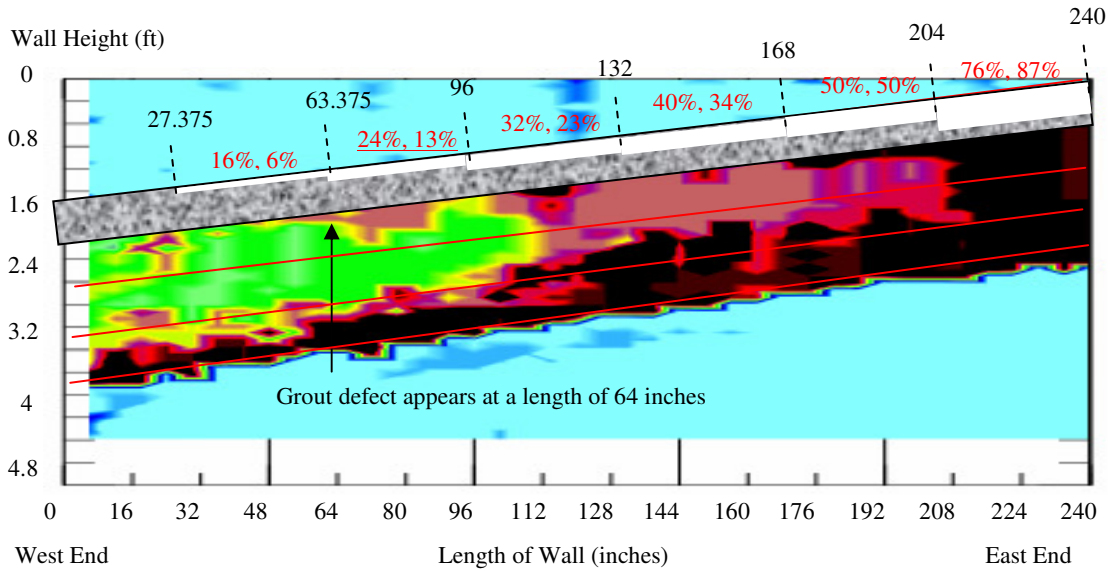
North Wall – Second Duct from Top: Several pieces of stepped Styrofoam were inserted inside this duct ranging from depth lost of 6% to 87% or circumferential lost of 16% to 76%. Review of Figure 9 shows that the grout defect started to appear at a length of 1.62 m (64 in) from the west end of the girder. This length corresponds with location with voids of 13% lost in depth or 24% circumferential lost.

FIGURE 9 – IE RESULTS FROM THE NORTH WALL WITH THE ACTUAL DESIGN DEFECTS OF THE SECOND DUCT

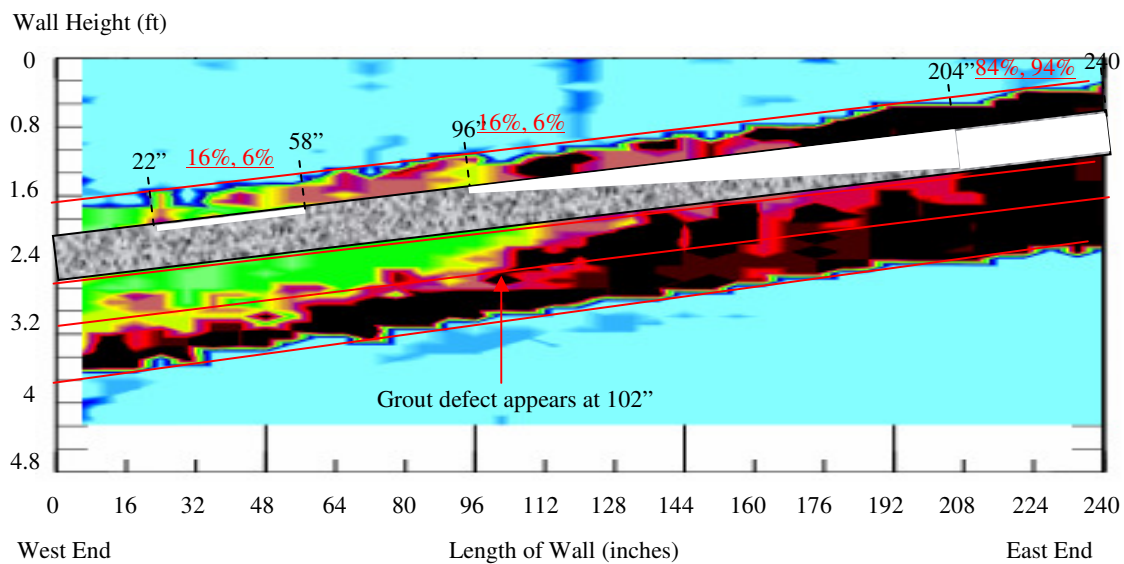
North Wall - Third Duct from Top: Review of Figure 10 shows that the grout defect started to appear at a length of 2.59 m (102") from the west end of the girder. This location corresponds to void of 11% depth lost or 19% circumferential lost. In this case, the grout defect appear to be apparent (full depth void) right at a length of 3.35 m (132 in) from the west end. This location corresponds to void of 35% depth lost or 39% circumferential lost.

FIGURE 10 – IE RESULTS FROM THE NORTH WALL WITH THE ACTUAL DESIGN DEFECTS OF THE THIRD DUCT

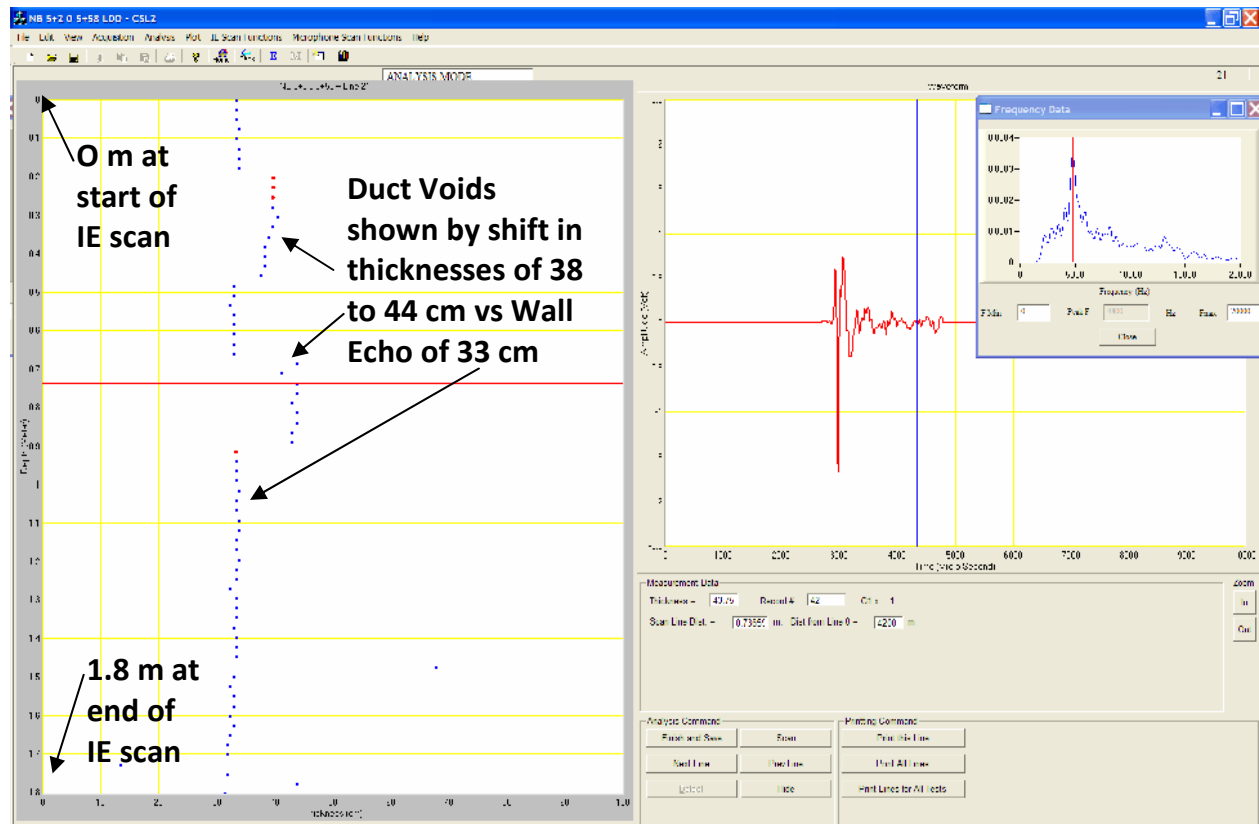
the bottom inside chamfer and ran to the top inside chamfer of the tested web walls for about 72 tests over 1.8 m of wall. A 2-D scan vertically up the wall from 0 to 2 m is shown in Figure 12. The 2-D results shows a single time domain result and the corresponding linear frequency displacement spectrum showing the resonant thickness echo peak along with the thickness vs. distance plot that is the 2-D IES result. Potentially voided ducts are indicated by the greater thicknesses in 2 locations (lower resonant frequency echo peaks due to voiding) in Figure 12. The results from the tests are presented in a thickness tomogram fashion for each web wall for each tested span with thicker areas indicative of potential void in the PT Ducts. An example test result from one of the spans is presented in Figure 13. Review of Figure 13 shows discontinuities or voids located at 20 m from Pier 2 and from the bottom of the wall (location where the scan started) to a height of 0.6 m. The IE records indicated cracks/voids at depths of 12 – 15 cm from the test surface. In addition, the plot in Figure 13 also indicated a thicker area (presented in black color) representing voids inside the duct(s) located at 42 m from Pier 2 and from heights of 0.9 – 1.15 m. The color map in Figure 13 shows normalized thicknesses (the IE thickness divided by the nominal thickness at the tested line) by color from 0.1 to 1.3.

FIGURE 12 – VERTICAL IMPACT ECHO SCAN WITH 2 DUCT VOIDS OF 33 CM THICK WALL SECTION WITH 100 MM DUCTS

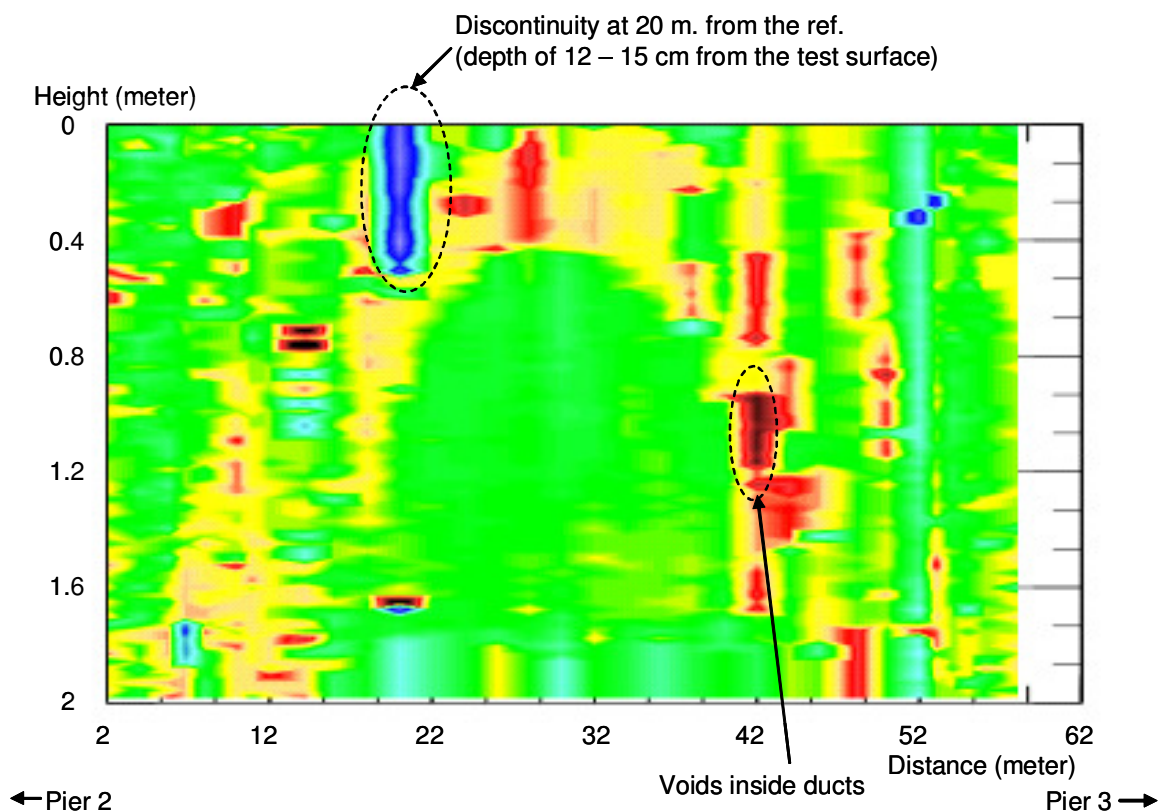
FIGURE 13 – 3D NORMALIZED THICKNESS TOMOGRAM OF SPAN 2 OF NORTH BOX (GENERAL CONDITION)
