# **SONIC PULSE VELOCITY TESTING TO ASSESS CONDITION OF A CONCRETE DAM**

*Edward D. Billington, AG&E-Schnabel, Greensboro, NC  
Dennis A. Sack and Larry D. Olson, Olson Engineering Inc., Wheat Ridge, CO*

A velocity analysis was performed to assess the condition of a concrete arch dam in western North Carolina. Sonic pulse velocity (SPV) measurements were made at 28 locations along the dam by impacting the downstream face and recording arrival times on the upstream face. The sonic energy was generating using a remotely operated impact source specifically designed for the project that could be lowered from the dam crest. The compressional wave energy was recorded using a string of hydrophones on the upstream face of the dam. A tomographic analysis of the arrival time data was performed to generate cross sections at each station to show the velocity distribution through the dam. An underwater inspection of the upstream face provided the opportunity to correlate velocity anomalies with diver observations. The results of the velocity analysis will serve as a baseline for future assessments of the dam.

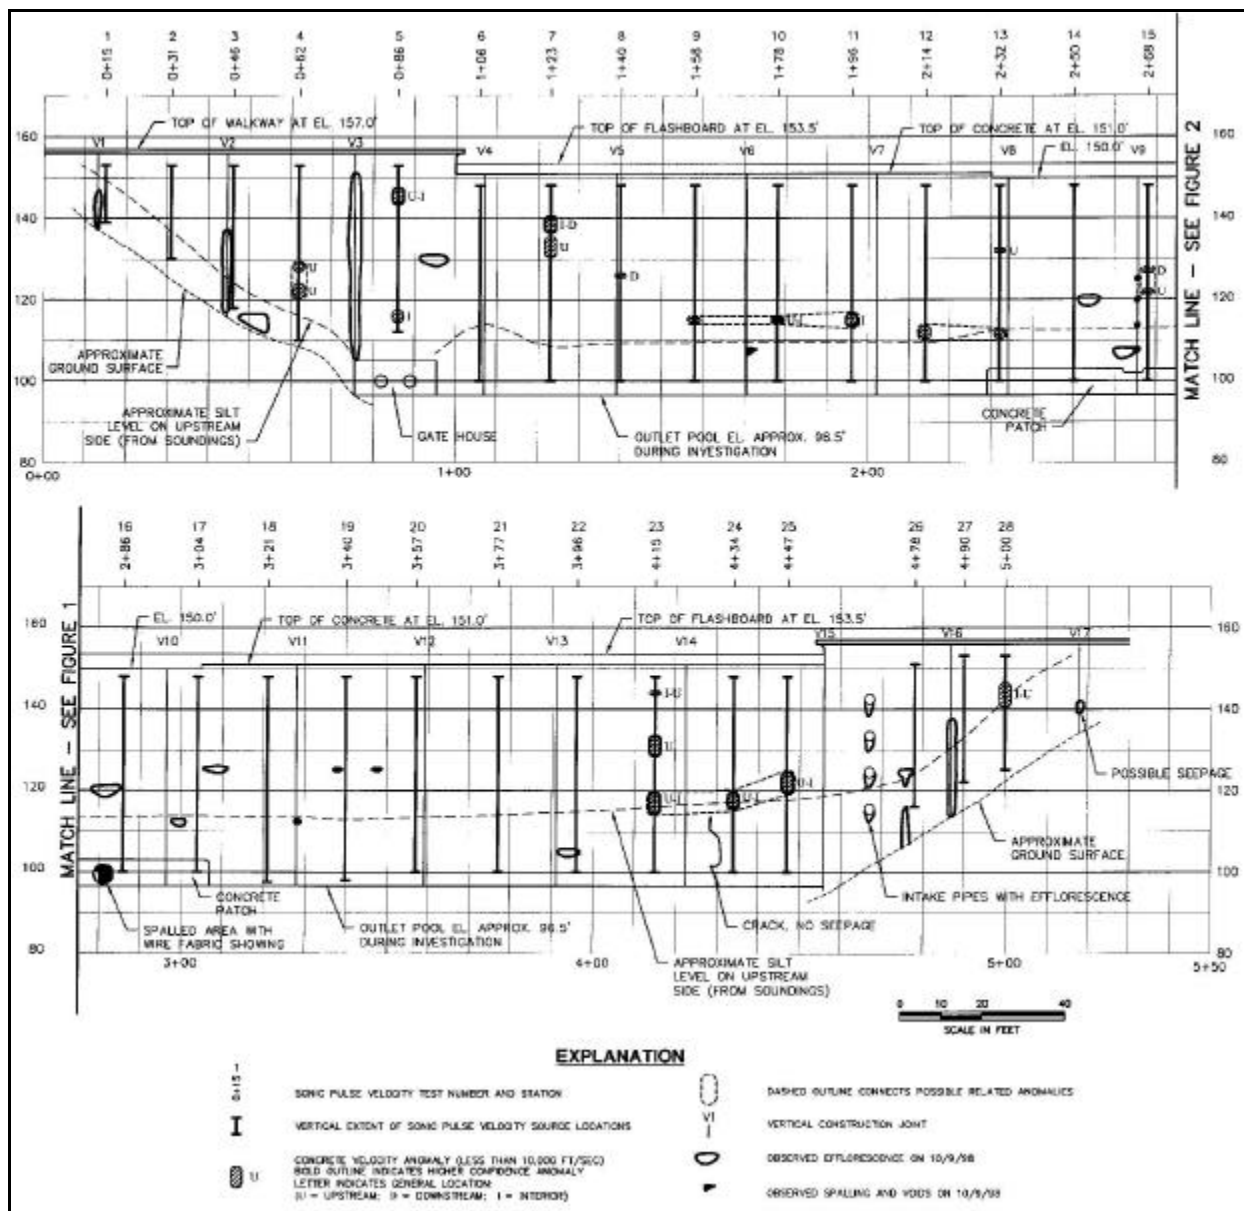
**Figure 6. Schematic elevation of dam (looking upstream) showing location of 1998 sonic tests, anomalous velocity areas, and visual observations.**

The condition of the concrete on the downstream face of the dam was observed on October 9, to note the location of efflorescence and spalling of the concrete (Figure 6). Most of the efflorescence appeared to be related to vertical and horizontal construction joints. Comparison of the concrete velocity anomalies with the approximate location of efflorescence does not show any obvious correlations, suggesting that the condition causing the efflorescence has not affected the strength of the concrete.

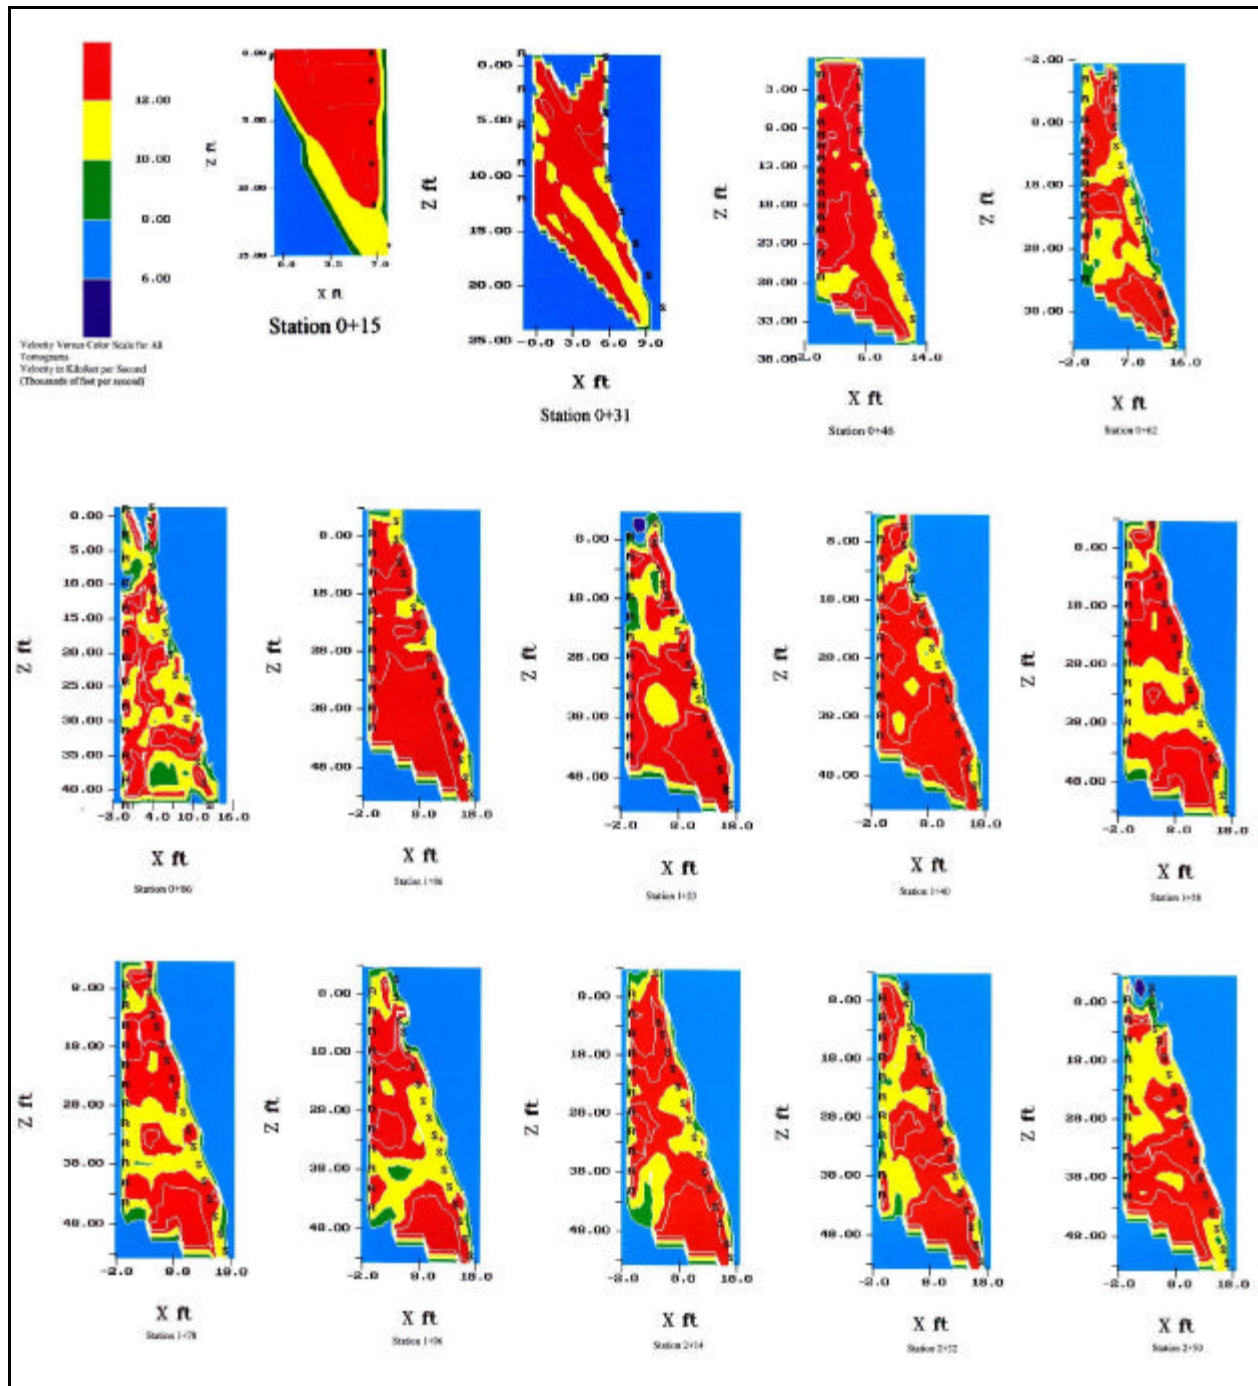
Figure 7. Tomograms for Stations 0+15 through 2+50

**Station 0+86:** This station is located above the center of the gate house, as shown on Figure 1. The tomogram for this station shows two low velocity anomalies. The anomaly from elevation 143.5 to 147.5 feet extends from the upstream side of the dam to the center of the dam. The anomaly from elevation 120.5 to 124 feet is in the interior of the dam directly above the gate house but is considered lower confidence due to the small number of raypaths through this area.

**Station 1+23:** The tomogram for this station shows an anomaly from elevation 143.5 to 147.5 feet between the center of the dam and the downstream face. The vertical orientation of this anomaly is suggestive of a vertical joint, crack, or weak zone. A low confidence anomaly is also noted from about elevation 130.5 to 135.5 feet near the upstream face.

**Stations 1+78 and 1+96:** A small, apparently horizontal anomaly at Station 1+78 at elevation 115.5 feet correlates with a larger anomaly at the same elevation at Station 1+96. In addition, the tomogram at Station 1+58 shows a velocity distribution that is very similar to that at Station 1+78, including a zone of lower velocity centered at elevation 115.5 feet. The alignment of these anomalies suggests a partially open, horizontal construction joint that is widest at Station 1+96 and becomes thinnest at Station 1+58. The lack of any efflorescence on the downstream face at this elevation indicates that if the anomaly is due to an open joint, it is not open through the dam.

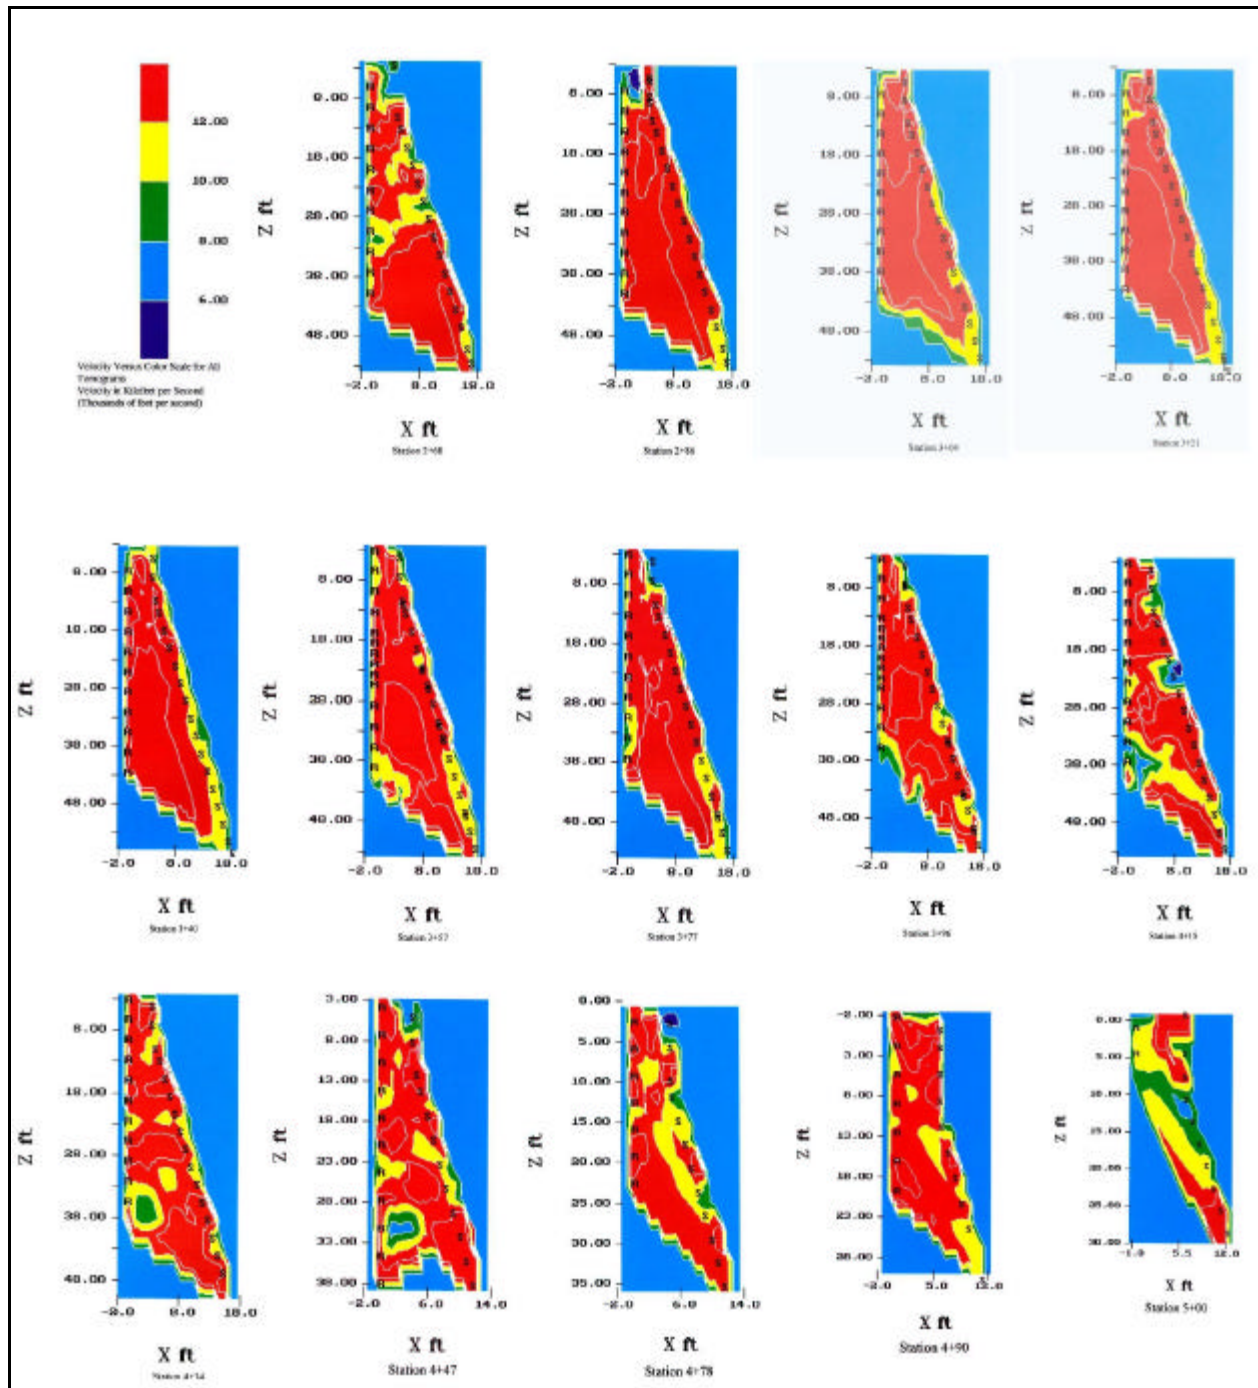
Figure 8. Tomograms for Stations 2+68 through 5+00

**Stations 4+15, 4+34, and 4+47:** A relatively large anomaly is present at about the same elevation (114.5 to 119.5 feet) at Stations 4+15 and 4+34. The anomaly at Station 4+47 is slightly higher in elevation but is similar in size and shape, suggesting a possible relationship between these anomalies. Station 4+15 shows another higher confidence anomaly at elevation 128.5 to 133.5 feet near the upstream face.
