Fusion of NDE Scanning and Photogrammetric Data for Concrete Bridge Decks and Girders Condition Assessment

Larry D. OLSON^{1*}

¹ Olson Engineering, Inc.; Wheat Ridge, Colorado, USA

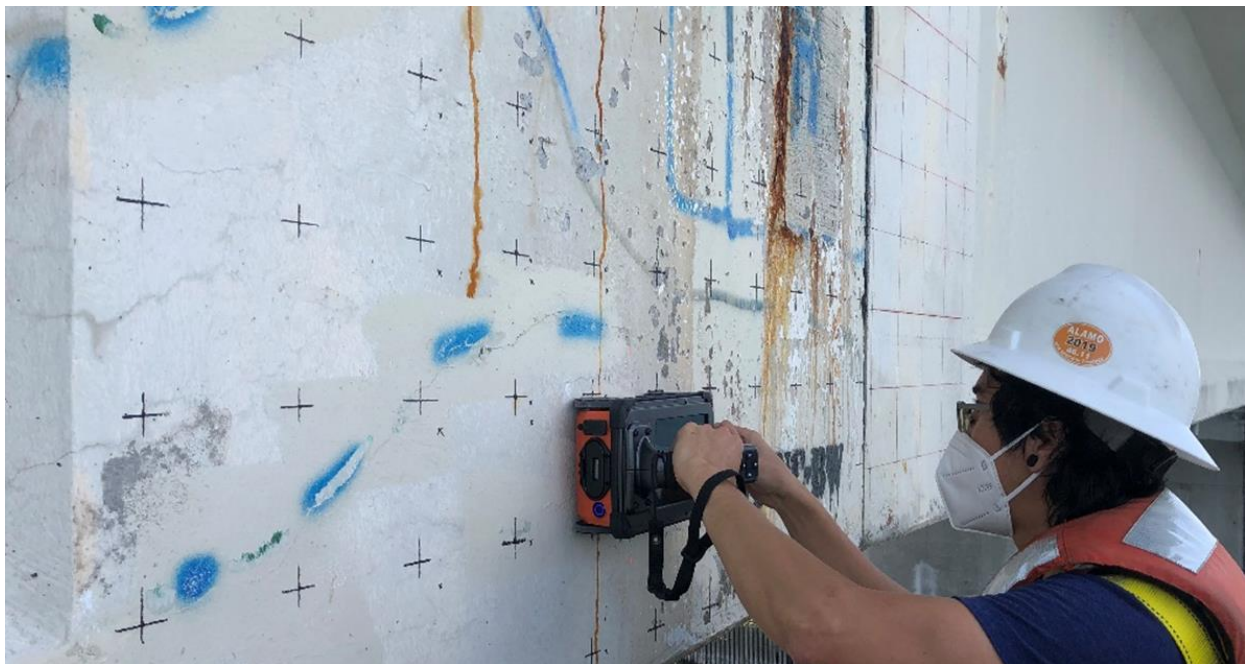
Figure 3: Horizontal GPR scanning on a 3 in (75 mm) grid (vertical scans were also completed) for 3-D GPR image

The GPR method involves moving an antenna across a test surface while periodically pulsing the antenna and recording the received echoes (Fig. 2). A handheld GPR unit was used to scan the girder webs and ends both vertically and horizontally (Fig. 3) in order to produce 3-D images

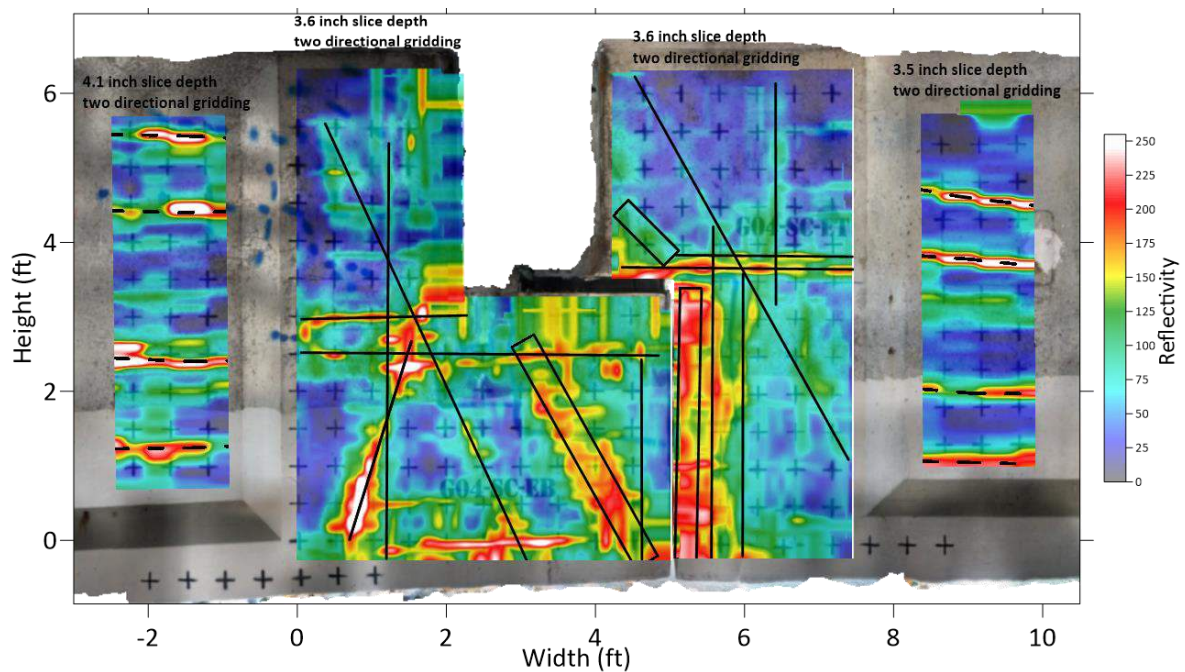
Figure 5: Data fusion – 3-D GPR depth slices for PT ducts, rebar and embedded plates

of embedded pre-stress, post-tensioning ducts, reinforcement, and steel plates in the girders. The raw GPR data from a vertical 2-D straight scan line is presented in Figure 4(a) with the hyperbolic-shaped reflections at a 2 in (50 mm) concrete cover depth indicating the near-surface horizontal rebar. Note the post-tensioned metal tendon ducts are larger in diameter and have broader and deeper hyperbolic reflections at 3 to 4 in (75 to 100 mm) deep. The GPR data is then migrated to collapse the rebar and duct reflections to a dot shape as shown in Figure 4(b). The final step is a Hilbert Transform that further clarifies the depths and locations of the rebars as the pulses are merged into a single pulse envelope as shown in Figure 4(c). The horizontal and vertical processed 2-D GPR scans were then combined to produce the 3-D GPR image that is overlaid on the photogrammetric image (Fig. 5). Review of this figure reveals the locations of embedded rebar, tendon ducts and metal plates overlaid on the photogrammetric image in Figure 1.

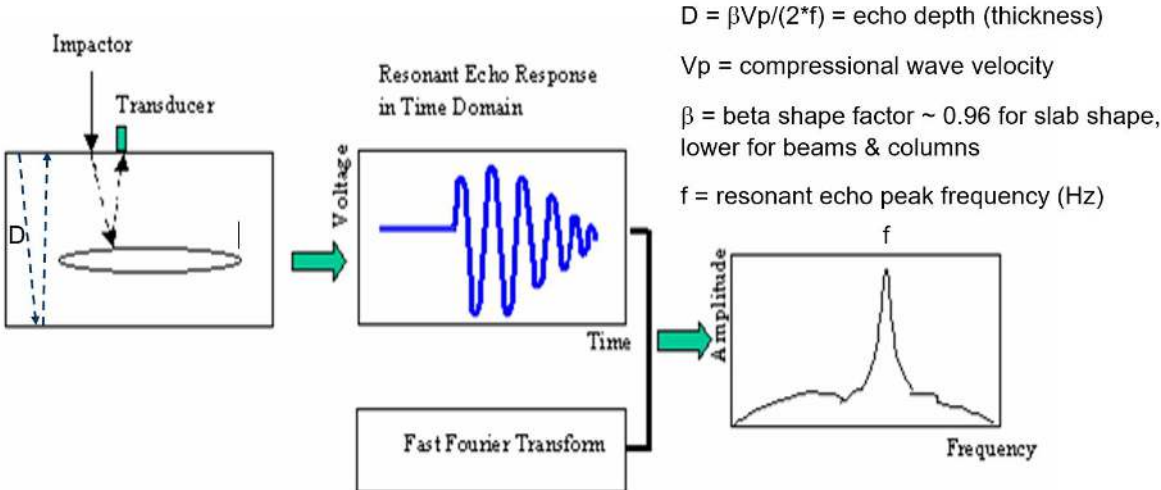
Figure 6: Impact echo test method and data analysis steps

The impact echo test method is ASTM Standard C1383-15 [4] and based on impacting the concrete and recording the resulting compressional wave echoes with a receiver in the time domain and analyzing the time data to obtain the resonant echo frequency with a Fast Fourier Transform (Fig. 6). The bridge girders were tested with an impact echo scanner that consisted of a rolling displacement transducer/solenoid impactor scanner system that covers more testing area in less time with a test every 1 in (25 mm) on vertical scan lines spaced 6 in (150 mm) apart (Fig. 7). The IES unit was used to check the concrete thickness/integrity and to detect voided vs. grouted post-tensioned tendon duct conditions in the web walls. Sound concrete web wall and grouted duct conditions are shown on a thickness echo plot on the left in Figure 8. Sound concrete web wall with a poorly grouted/void tendon duct condition are indicated by the increase in thickness echo on the right in Figure 8.

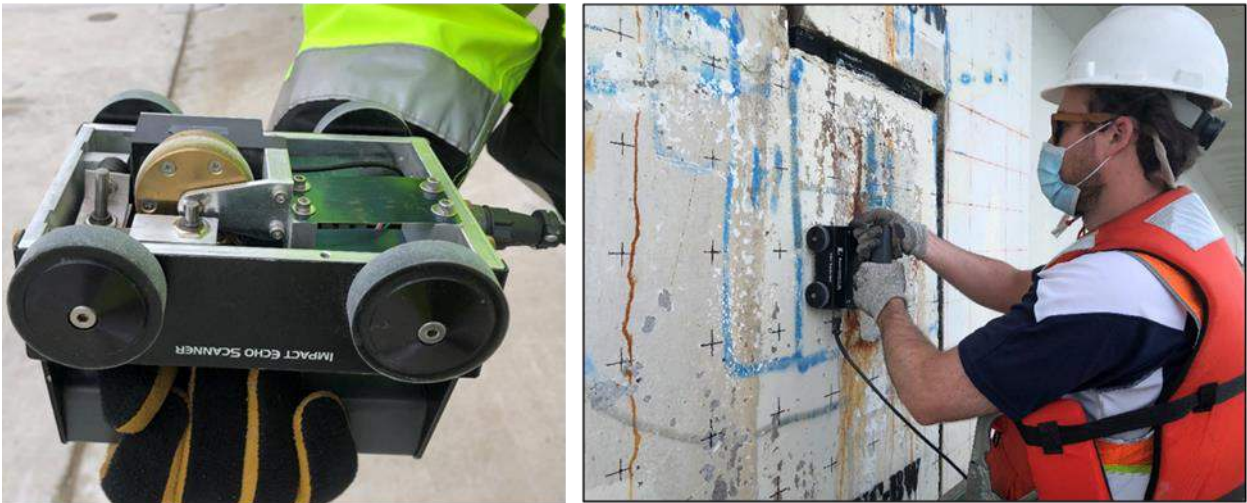
Figure 7: Impact echo scanner with rolling transducer wheel and solenoid impactors (left) and impact echo scanning of girders on vertical lines at 6 in (150 mm) spacing (right)

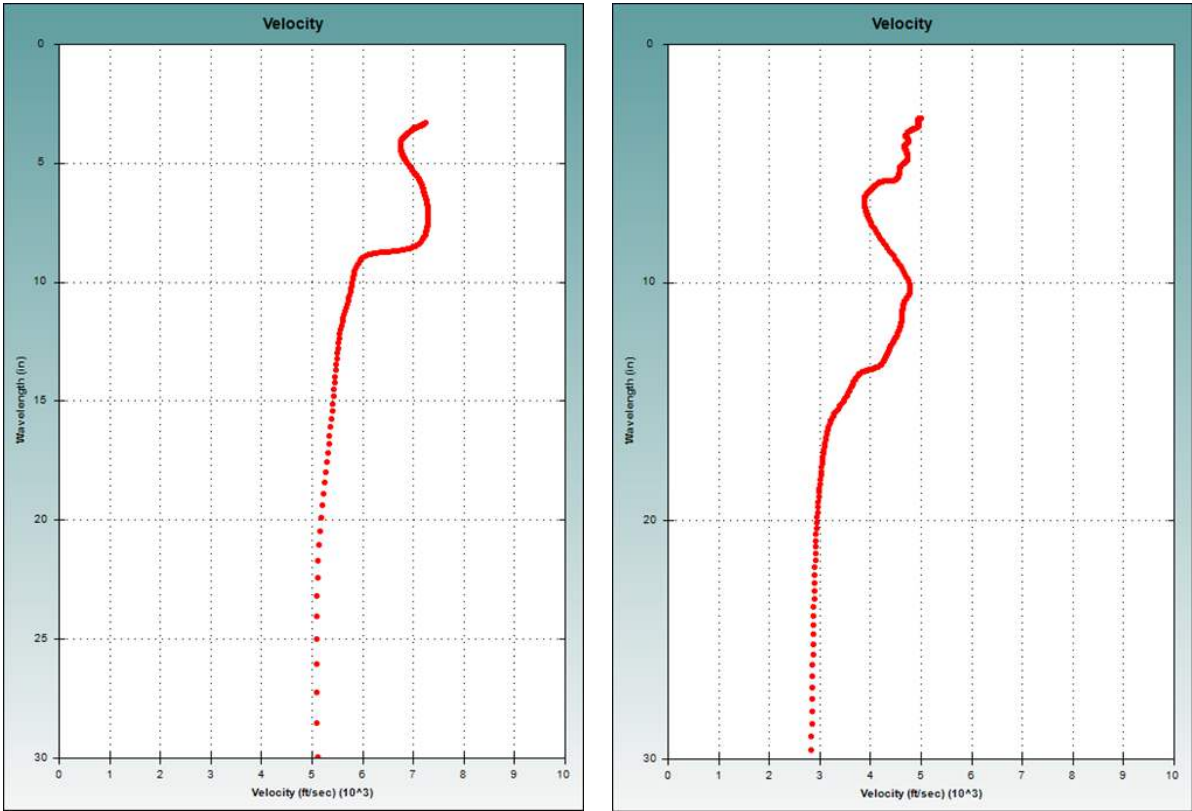
Figure 10: SASW velocity vs. wavelength results on sound (left) and visibly cracked (right) girder areas. The backside of the sound 7.5 in (190 mm) thick web section is shown by the drop in surface wave velocity from approximately 7,000 ft/s from 4 to 8 in (100 to 200 mm) to approximately 5,500 ft/s at a wavelength of 8 in (200 mm) (left). The SASW test across a crack on a girder end indicates a crack depth from the surface to approximately a 7 to 8 in (175 to 200 mm) depth where the surface wave velocity increases (right)

The SASW method measures the propagation speed of surface waves with various wavelengths (Fig. 9) for tests across a crack to determine its depth. Short wavelength waves sample shallow, longer wavelengths sample deeper and surface wave velocity = frequency x wavelength. SASW testing allows the measurement of the velocity profile versus depth into the structure, which can be related to the strength and condition of the concrete versus depth and the depth/extent of cracking damage. Refer to the ACI 228.2R[5] report on Nondestructive Test Methods for Evaluation of Concrete in Structures for detailed information on the SASW, IE and GPR methods. SASW velocity vs. wavelength plots (dispersion curves) are presented for sound concrete on the left in Figure 10 and for cracked concrete on the right in Figure 10. Review of these plots indicates a crack depth extending to about 7 to 8 in (175 to 200 mm) deep in the right plot where the surface wave velocity increases.

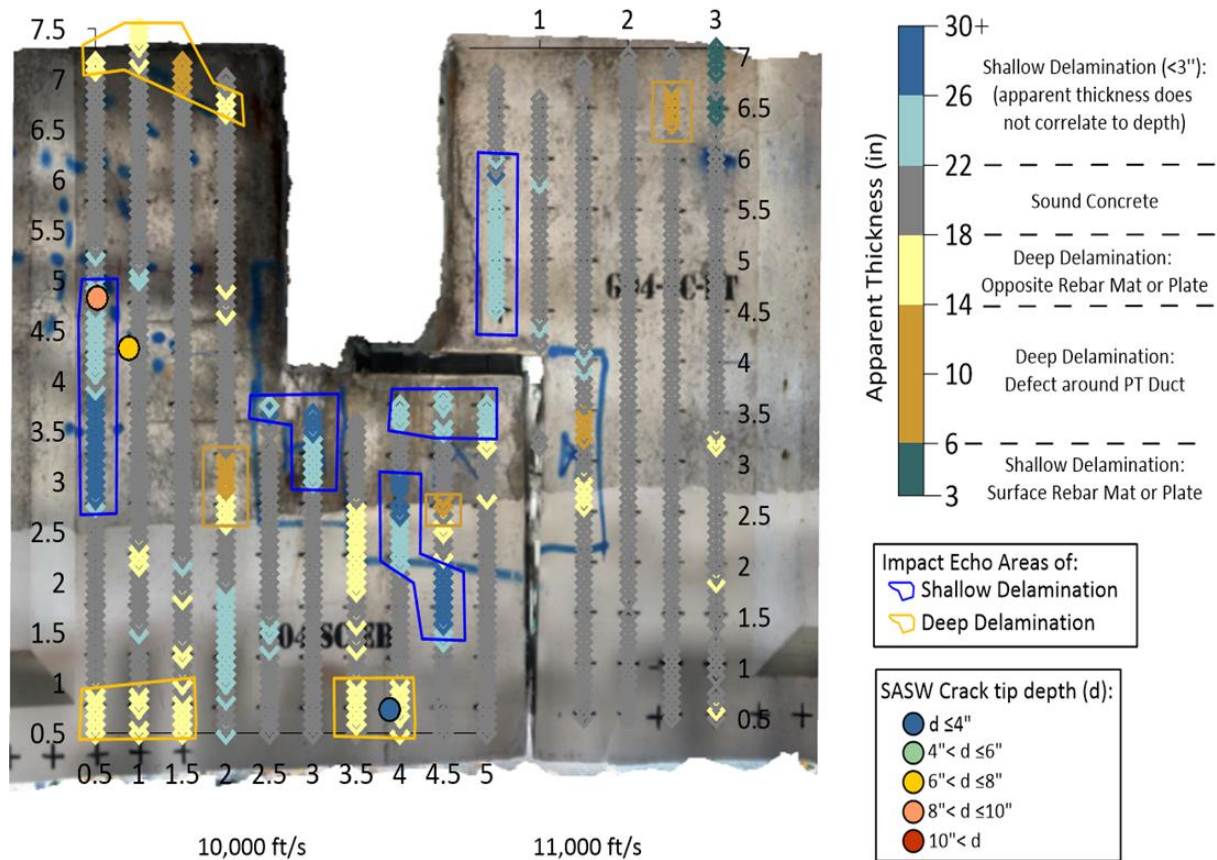
Figure 12: Data fusion for girder end walls of photogrammetric images, impact echo scanning, SASW and GPR results for duct grouting, crack tip depth and duct locations

The IES and SASW results were fused (overlaid) onto the photogrammetric image (Fig. 11) along with the GPR 3-D locations of the tendon ducts. Review of this figure provides combined data as to where the tendon ducts are (from GPR) and their grout conditions (from IES) plus crack depth data (SASW colored circles) and the surface conditions of the photogrammetric image for the web walls. An overall fusion image plot for the girder end walls of the IES and SASW results is presented in Figure 12. Note that this figure provides combined data as to the locations and depths of shallow to deep delaminations (from the IES results) along with crack depth data (SASW colored circles) and the surface conditions of the photogrammetric image.

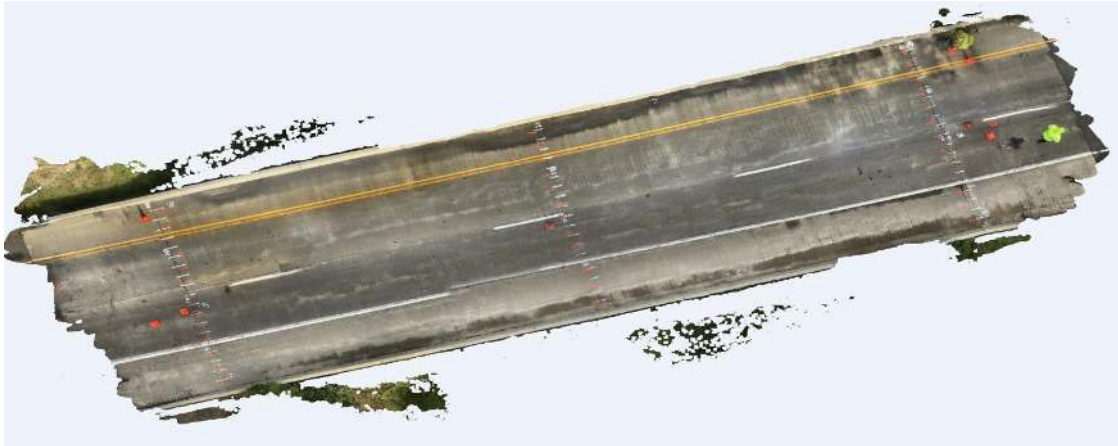
Figure 13. Digital orthomosaic (photogrammetric image) of concrete bridge deck

The photogrammetry approach is described above in Section 2.1. The process is the same for bridge girders and bridge decks. A photogrammetric image of the bridge deck is presented in Figure 13 below.
