Nondestructive evaluation of concrete dams and other structures

Larry D. Olson, P.E. (Presenter); Dennis A. Sack

Olson Engineering, Inc.
14818 W. 6th Ave Unit 5A, Golden, CO 80401

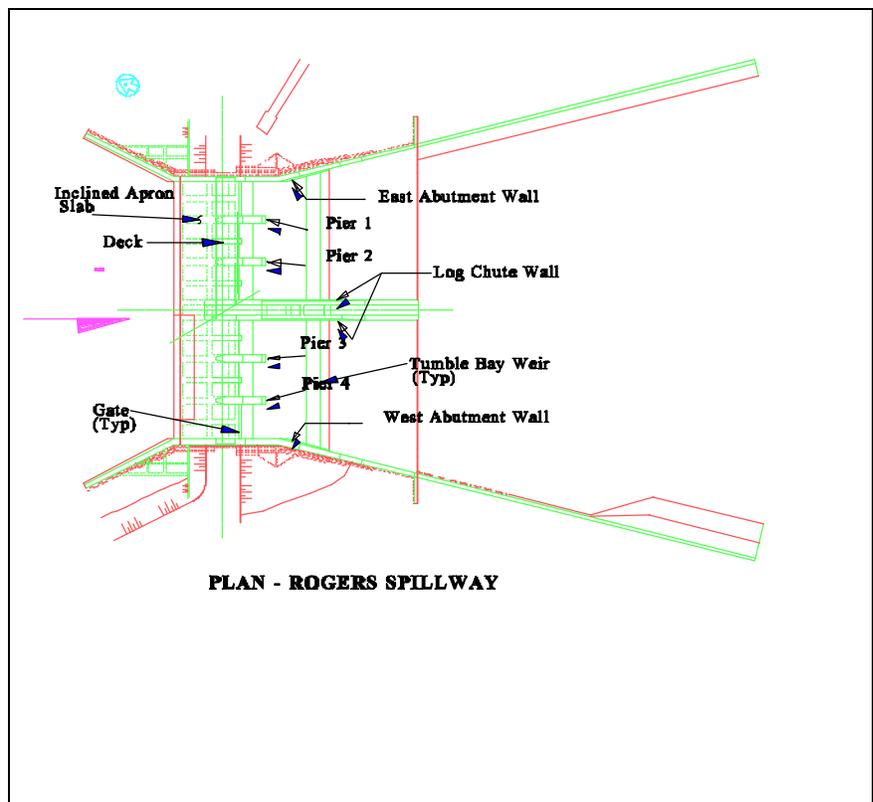
The concrete spillway structure is 156 feet wide, 193 feet long and 36 feet high. The structure supports six radial tainter gates, each 20 feet wide and 12 feet 6 inches high, and a central log chute, six feet wide. The general arrangement of the spillway is shown in Fig. 1. The spillway is constructed of unreinforced, mass concrete without air entrainment and has suffered freeze/thaw damage throughout its life. The concrete has frequently been repaired. Recent repairs in 1985 involved removing the damaged concrete and resurfacing it with shotcrete.

Field observation in 1991 revealed that the repaired spillway structure had extensively degraded. The characteristic patterns of alligator cracking were prevalent, and

shotcrete surface at many locations produced a hollow sound when struck by a hammer, indicating that the surface shotcrete had debonded from the interior concrete.
