# **SONIC PULSE VELOCITY TESTING TO ASSESS CONDITION OF A CONCRETE DAM**

*Edward D. Billington, AG&E-Schnabel, Greensboro, NC  
Dennis A. Sack and Larry D. Olson, Olson Engineering Inc., Wheat Ridge, CO*

A velocity analysis was performed to assess the condition of a concrete arch dam in western North Carolina. Sonic pulse velocity (SPV) measurements were made at 28 locations along the dam by impacting the downstream face and recording arrival times on the upstream face. The sonic energy was generating using a remotely operated impact source specifically designed for the project that could be lowered from the dam crest. The compressional wave energy was recorded using a string of hydrophones on the upstream face of the dam. A tomographic analysis of the arrival time data was performed to generate cross sections at each station to show the velocity distribution through the dam. An underwater inspection of the upstream face provided the opportunity to correlate velocity anomalies with diver observations. The results of the velocity analysis will serve as a baseline for future assessments of the dam.

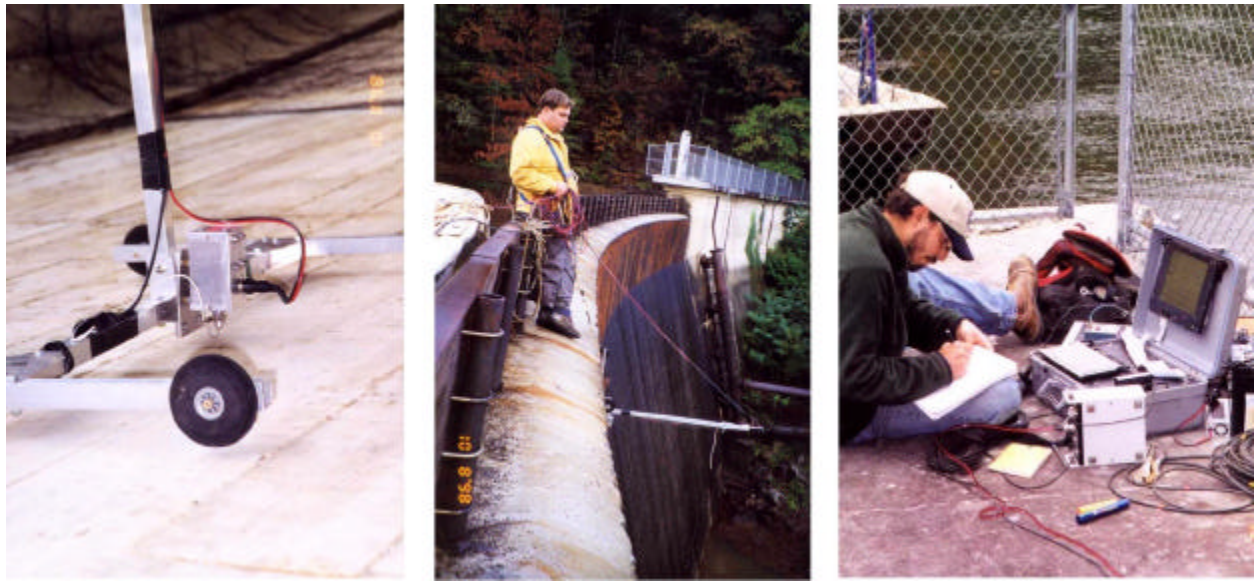
**Figure 2. Photographs from October 1998 data acquisition. From left: Closeup of solenoid-actuated sonic impact source; lowering source from top of dam; recording data at station near left abutment. For most stations, the recording unit was in a boat.**

Problems encountered during the field work included difficulty in obtaining a sufficient signal at some locations due to buildup on the downstream dam face. In these instances, the impact source was moved slightly up or down the dam face, or slightly to either side, until a signal of sufficient amplitude was obtained. The intakes for the fish hatchery on the left side of the dam were open during the test, causing some background noise that reduced the confidence level of the first arrivals for records obtained close to the intakes.

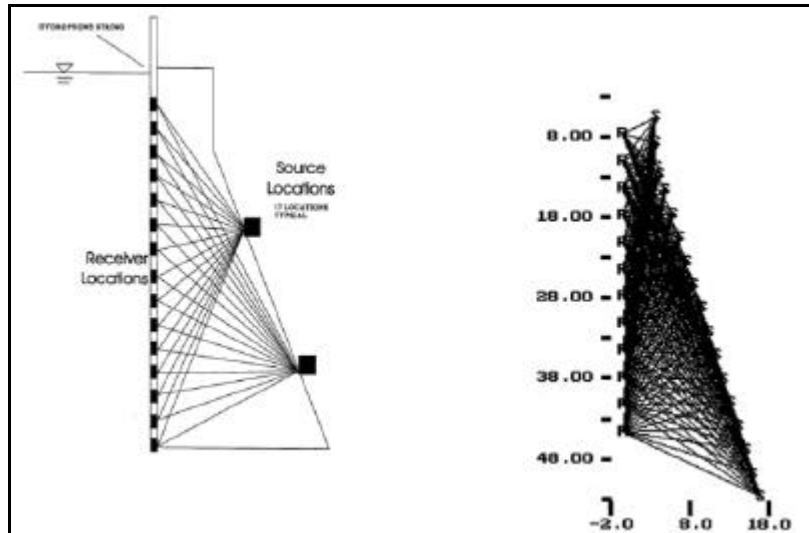
**Figure 3. Schematic raypath geometry (on left) and raypath density plot for typical station.**

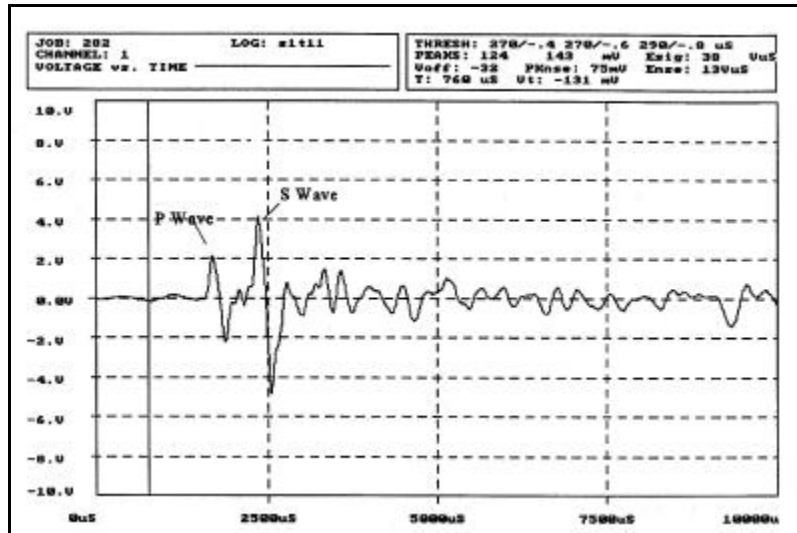
**Figure 4. Example trace showing P-wave and S-wave arrivals through dam. Note high signal-to-noise ratio.**

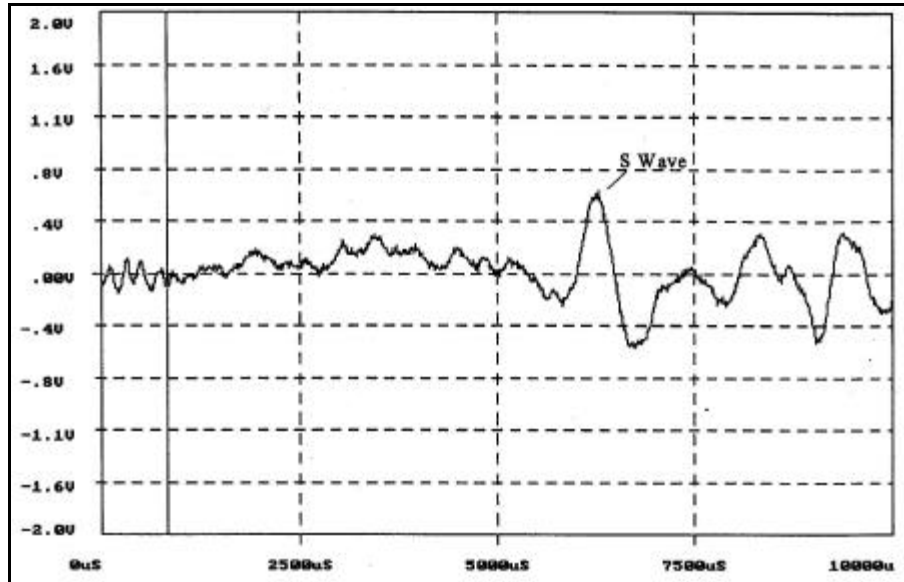
**Figure 5. Example data trace showing low signal-to-noise ratio and no clear P-wave arrival. Note the strong S-wave arrival that was used in these instances.**
